# Building Inspection Report

1234 J Street Napa, CA

Inspection Date: 8/30/2017

Report Number: 20171375

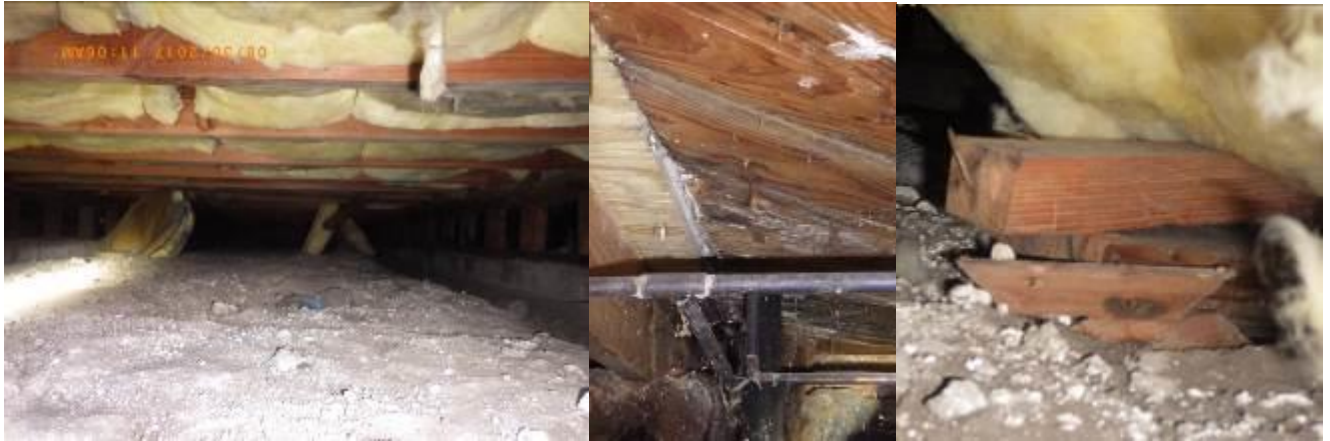
- **Monitor:** There is evidence of seasonal water in the crawl space. Wet crawl spaces risk building damage from rot and insects and can cause interior mold or mildew. This condition may vary seasonally and/or with precipitation intensity. Roof and lot drainage repairs or improvements should be addressed as a first step to controlling water in the crawl space (see Exterior and/or Roof). This condition should then be monitored to determine if additional, potentially costly measures are necessary to protect the building interior from water and moisture damage.

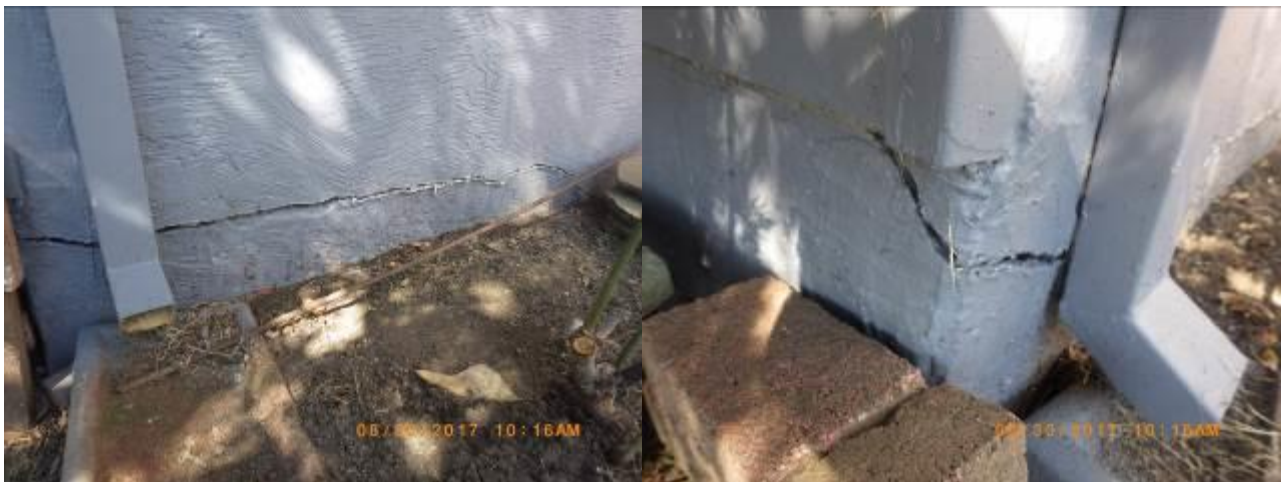
- **Major Concern, Repair:** Pronounced exterior wall cracks were observed. This implies that structural movement of the building has occurred. While the rate of movement cannot be predicted during a one-time inspection it is likely that repairs are needed. A structural engineer or a repair specialist who is familiar with residential building failures should be consulted to further evaluate this condition and the remedies available. Recommend a qualified contractor tuck point as needed.

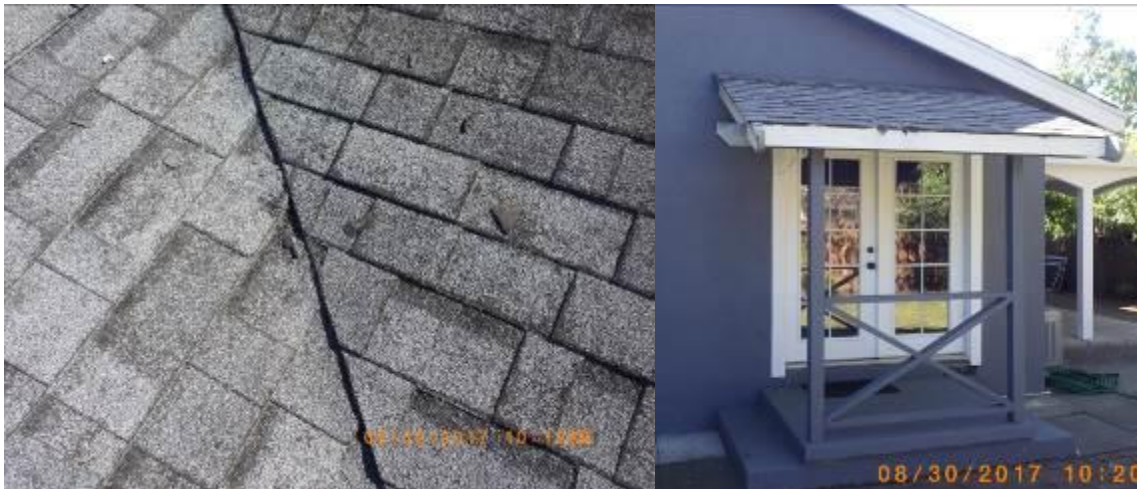
- **Deferred Cost Item:** The roofing is near the end of its life. Minor repairs might be possible to extend the roof life and to defer leaks. Damaged or missing roofing material should be repaired. All roof penetrations should be examined and sealed as necessary. Expect to replace the roof soon.
- **Monitor:** Prior repairs to the roofing are evident. This would suggest that problems have been experienced in the past. This area should be monitored.

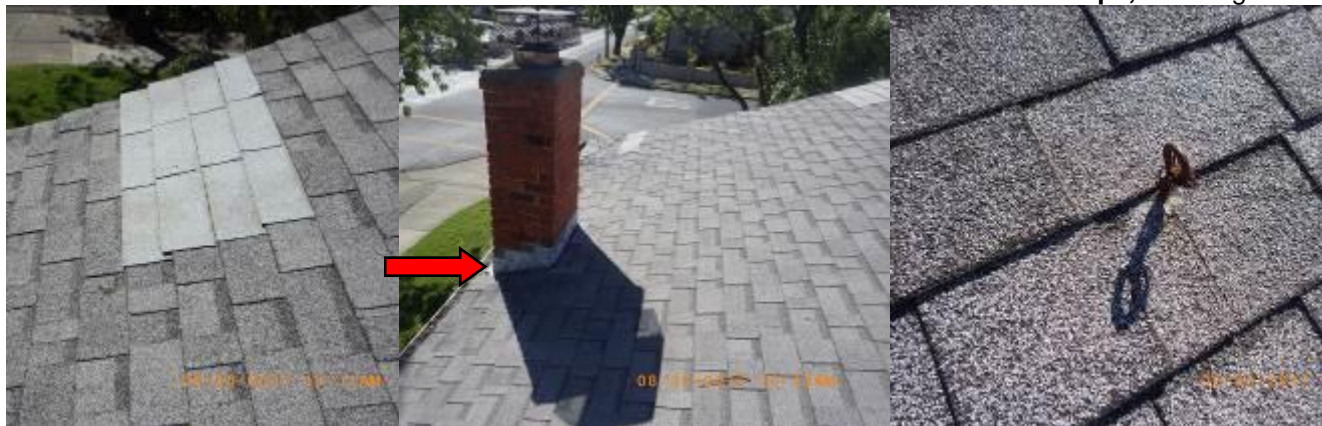
- **Repair:** The flashing is rusting. It should be painted to extend its life. Nail heads are exposed at the flashing. They should be sealed to reduce risk of leaks.

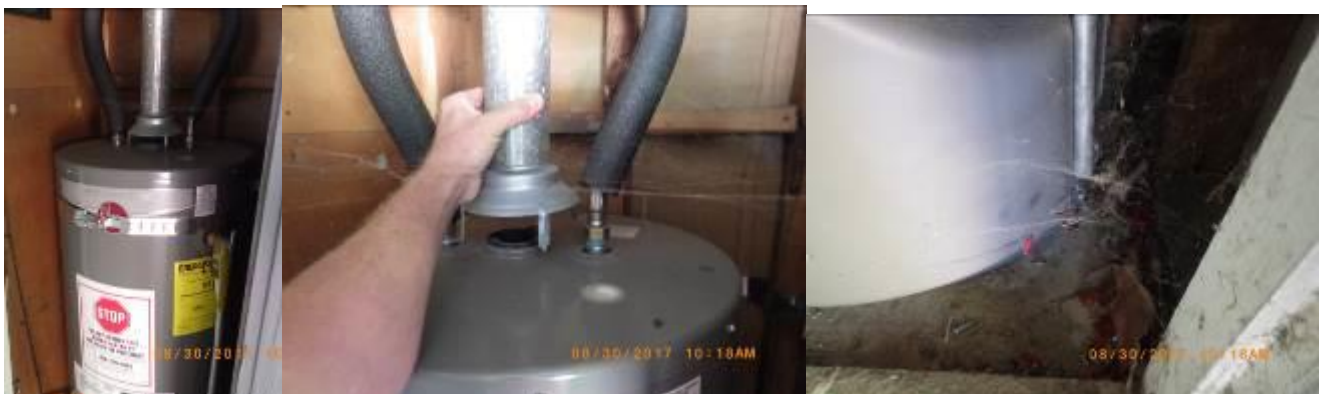
- **Repair:** The discharge piping serving the Temperature and Pressure Relief (TPR) Valve for the water heater should terminate not less than 6 inches or more than 24 inches above the ground outside.
- **Repair:** For enhanced safety, it is recommended that the connections of the water heater venting system be improved.
- **Repair:** Water heaters in seismic zones should be **properly** anchored or strapped to resist movement during earthquake conditions.

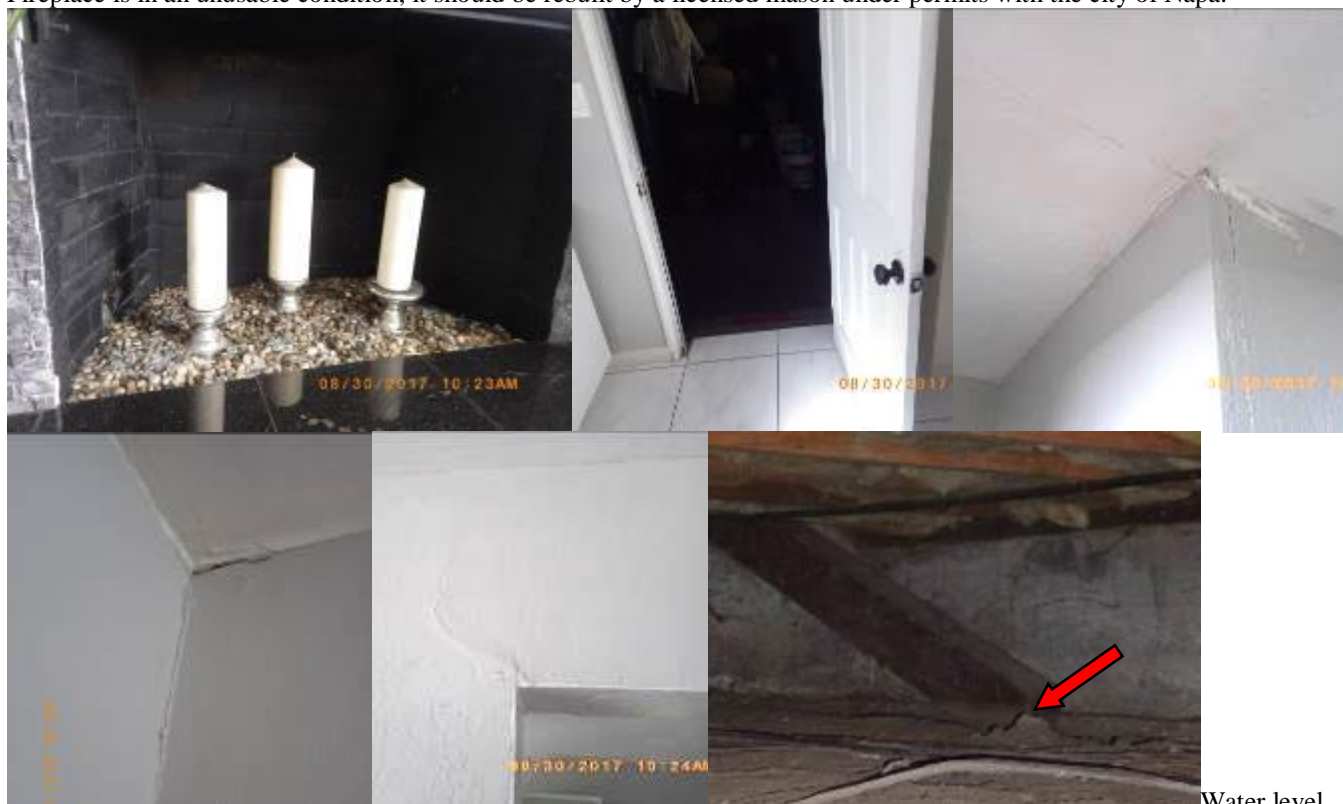
Fireplace is in an unusable condition; it should be rebuilt by a licensed mason under permits with the city of Napa.
