# Building Inspection Report

1234 J Street Napa, CA

Inspection Date: 8/30/2017

Report Number: 20171375

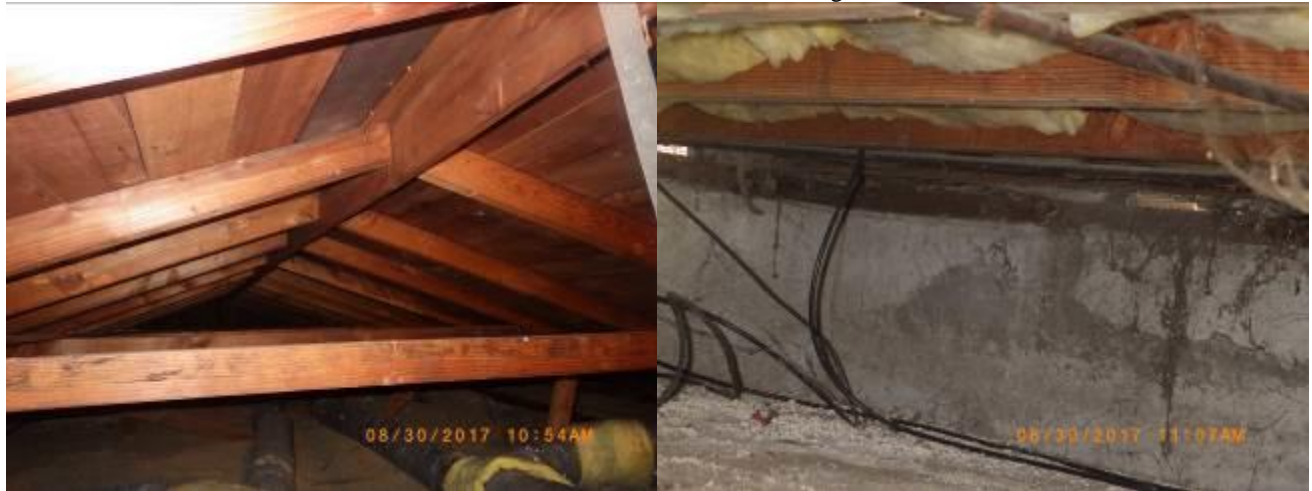
- **Monitor:** Minor settlement cracks were observed in the brickwork and stucco walls. This implies that some structural movement of the building has occurred. Cracks of this type should be watched for any sign of additional movement. In the absence of any sign of ongoing movement, repair should not be critical. *The chimney must come down; it's broken at the roofline and is a serious safety hazard to residents and the public on the sidewalk out front.*
- **Major Concern:** The garage slab & perimeter foundation shows evidence of cracking and heaving. Given the history of this area, it is likely that this condition is the result of expansive soil conditions combined with seismic events. This can be a serious structural problem. A structural engineer who is expert regarding expansive soils should be consulted to further evaluate this condition and the remedies available.

- **Monitor:** The floor structure shows common sagging and movement. This is usually the result of the age and framing design of the building.
- **Major Concern, Repair:** The floor structure shows evidence of substantial rot below the bathrooms. Some repairs were done, some rot remains. Rot weakens the structure and causes building damage. Rot develops where untreated wood is in contact with moisture and/or where wood/soil contact exists. Damaged wood should be repaired or replaced and the conditions that have promoted the rot should be corrected. A framing repair company or structural engineer who is expert in wood framing be consulted to further evaluate this condition and the remedies available.

- **Major Concern, Repair:** Pronounced exterior wall cracks were observed. This implies that structural movement of the building has occurred. While the rate of movement cannot be predicted during a one-time inspection it is likely that repairs are needed. A structural engineer or a repair specialist who is familiar with residential building failures should be consulted to further evaluate this condition and the remedies available. Recommend a qualified contractor tuck point as needed.

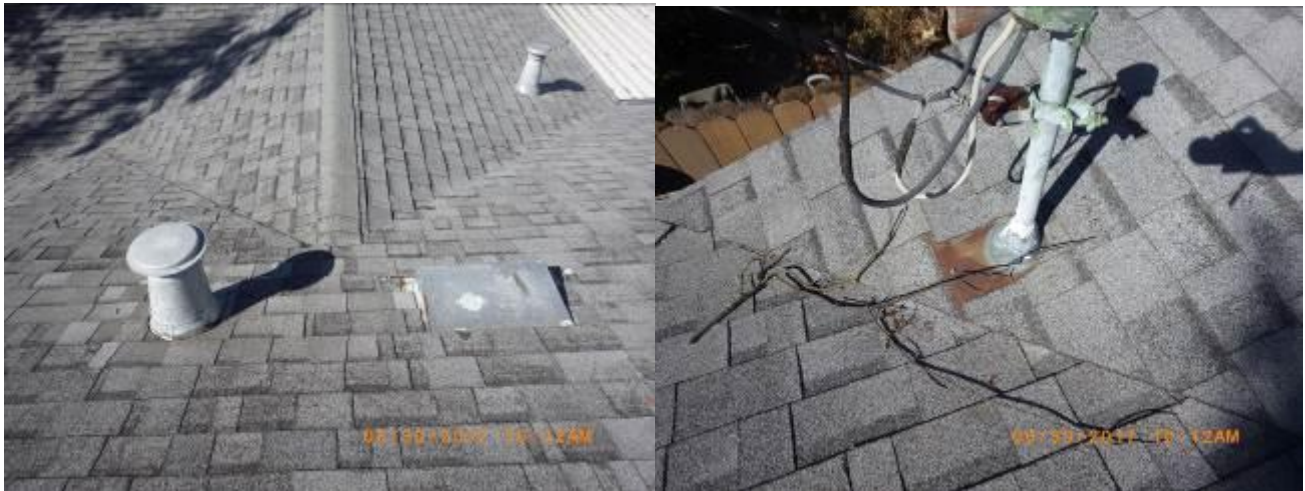
- **Deferred Cost Item:** The roofing is near the end of its life. Minor repairs might be possible to extend the roof life and to defer leaks. Damaged or missing roofing material should be repaired. All roof penetrations should be examined and sealed as necessary. Expect to replace the roof soon.
- **Monitor:** Prior repairs to the roofing are evident. This would suggest that problems have been experienced in the past. This area should be monitored.

- **Repair:** The flashing is rusting. It should be painted to extend its life. Nail heads are exposed at the flashing. They should be sealed to reduce risk of leaks.

- **Major Concern, Repair, Safety Issue:** The masonry chimney shows evidence of substantial deterioration, broken at the roofline. Rebuilding from the shoulders up is needed to assure a safe and functional flue.

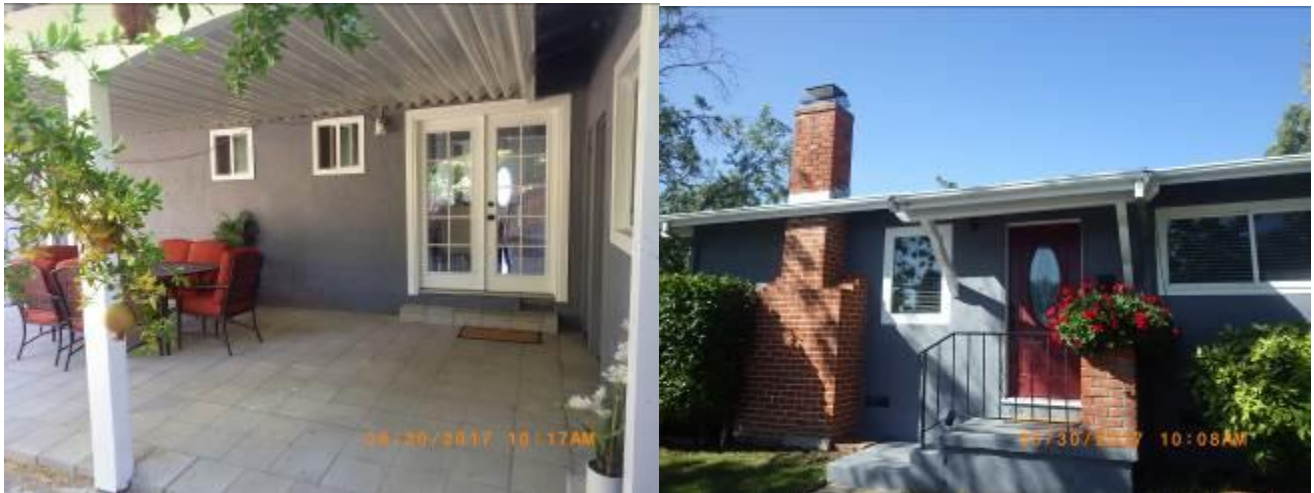
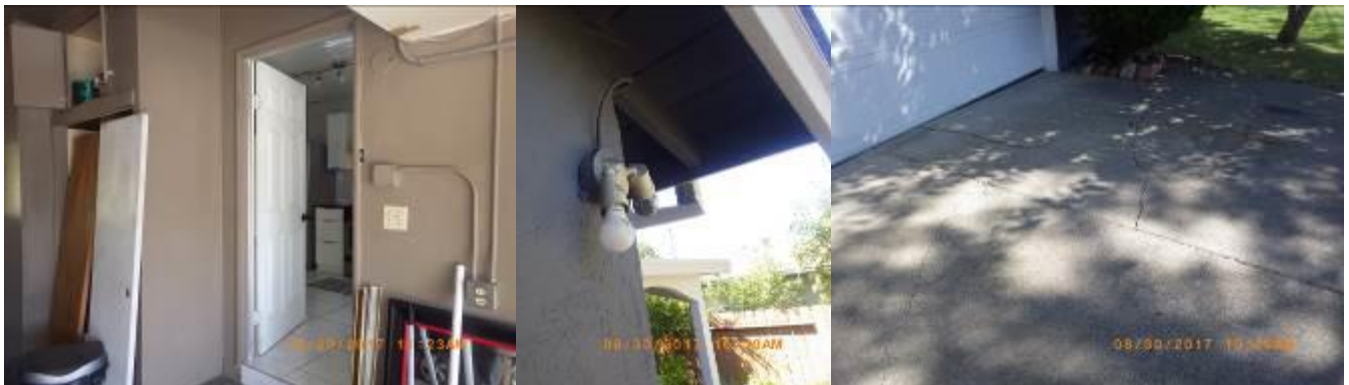
The exterior of the home has lacked some maintenance; repairs are needed.

- **Repair:** Localized pointing of deteriorated mortar between the bricks of the exterior walls is advisable to prevent further deterioration.
- **Repair:** Localized damage of the stucco exterior walls (staining and or cracks) should be repaired. There is extra risk of hidden damage in such areas caused by previous or present leaks that should be sealed.
- **Repair:** Tree branches should be trimmed away from the house.

- **Repair:** Vines growing on exterior walls should be kept trimmed away from siding, window trims, and the eaves to reduce risk of insect and water damage.

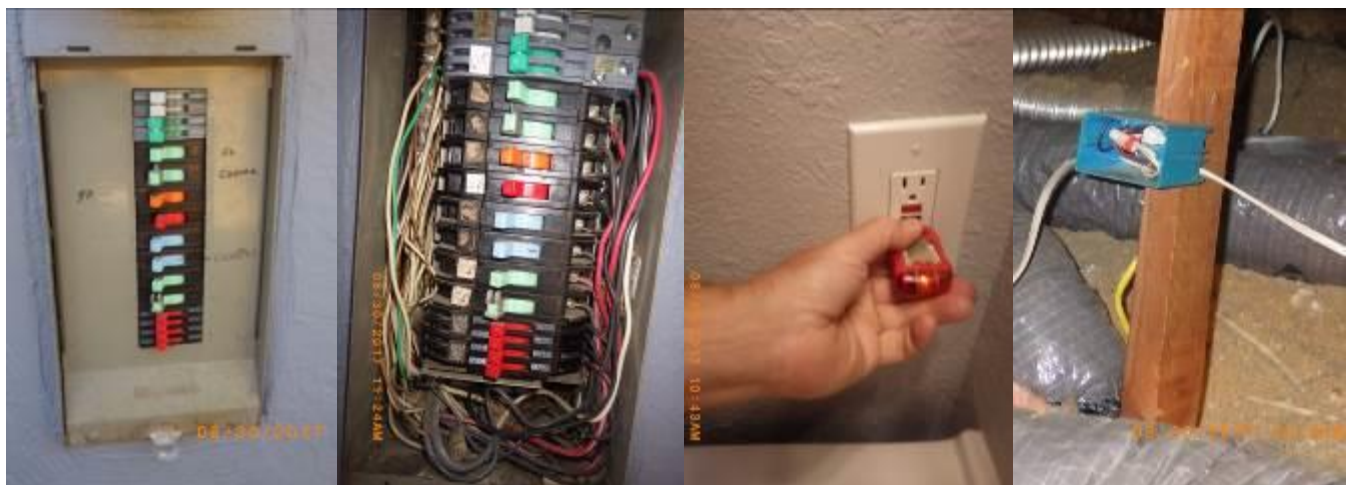
**Major Concern:** Inspection of the electrical system revealed the need for numerous repairs. These should be a high priority for safety reasons. *Unsafe electrical conditions represent a shock hazard.* A licensed electrician should be consulted to undertake the repairs recommended below.

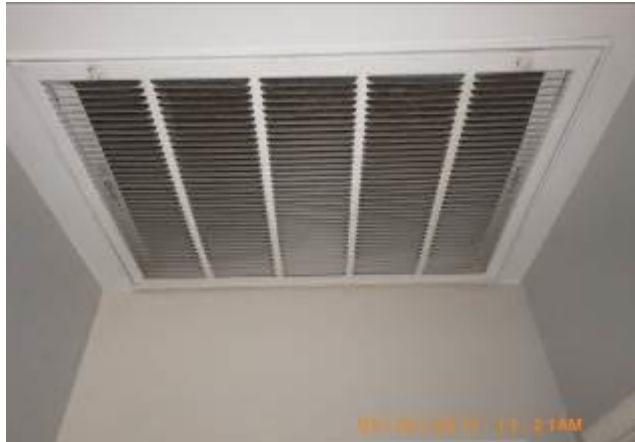
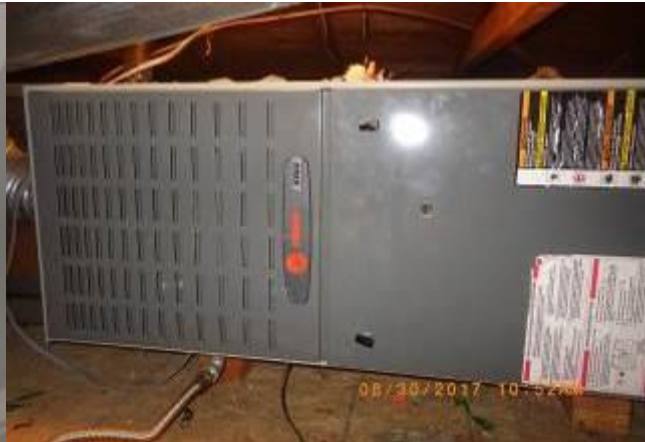
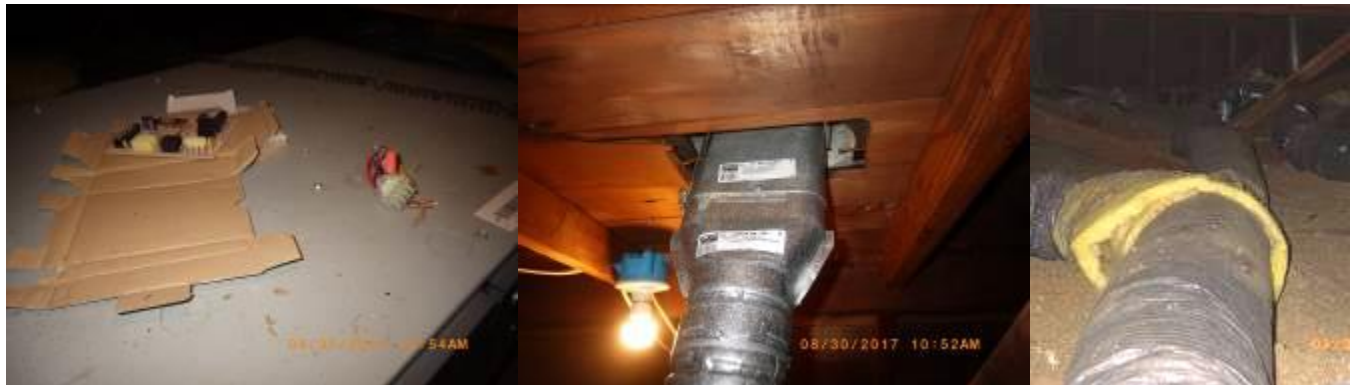
The heating system is newer and in generally good condition. Ask for warranty info & service records.

- **Monitor:** The heating system may require service. This should be a regular maintenance item to assure safe, reliable heat. The installation of a “set back” thermostat may help to reduce heating and cooling costs.
